Manhole Inspection Summary

Manhole # S41W__019MH

Insp Date: **10/10/08 1:37 PM**

Location Address: **1500 key hw.**

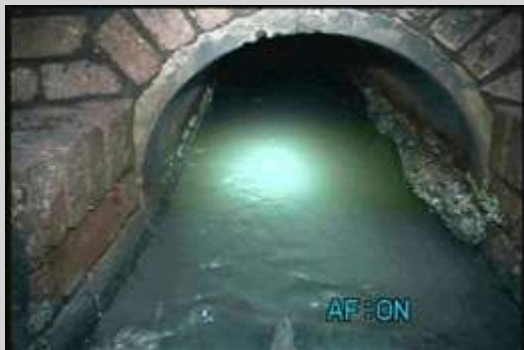
12 O'Clock Outflow

18 in. Circular Gravity Sewer
Pipe Out @ 12 O'Clock

Pipe Material: **Clay** ☐ Pipe Lined

Invert Depth: **8.25** (ft.) Flow Characteristics: **Fast**

Deposits: ☒ None ☐ Mud ☐ Sludge ☐ Debris ☐ Grease

Infiltration: **None** Pipe Seal Cond: **Unknown**

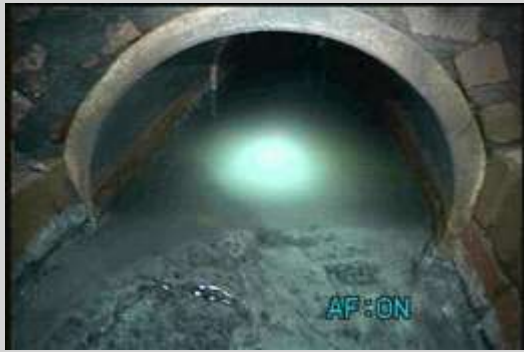
6 O'Clock Inflow

18 in. Circular Gravity Sewer

Pipe In @ 6 O'Clock

Pipe Material: **Clay** ☐ Pipe Lined

Invert Depth: **7.75** (ft.) Flow Characteristics: **Fast**

Deposits: ☒ None ☐ Mud ☐ Sludge ☐ Debris ☐ Grease

Infiltration: **None** Pipe Seal Cond: **Unknown**

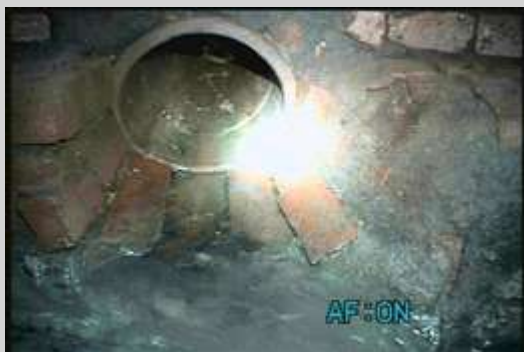
9 O'Clock Inflow

8 in. Circular Gravity Sewer

Pipe In @ 9 O'Clock

Pipe Material: **Clay** ☐ Pipe Lined

Infiltration: **None** Pipe Seal Cond: **Unknown**
